Xerox 7300 “Reset Toner Cartridge” Error - Modification

This modification comes at the suggestion of a former Xerox R&D engineer, and it's relatively easy to accomplish. My feeling is that there is not one single cause for this issue and so there's no guarantee, in my opinion, that this modification will solve the problem in every case. Nonetheless, it can only help by removing one possible cause, and in some instances it will no doubt provide a total cure. I have two machines, one has this modification, the other not. I will need more time to make an assessment of the results. The modification removes a acetate insulation sheet which protects connections on the Flag Sensor pcb, and replaces it with some insulating tape. It seems this acetate, which is not fixed in position, can sometimes move where it interferes with the movement of the flags.

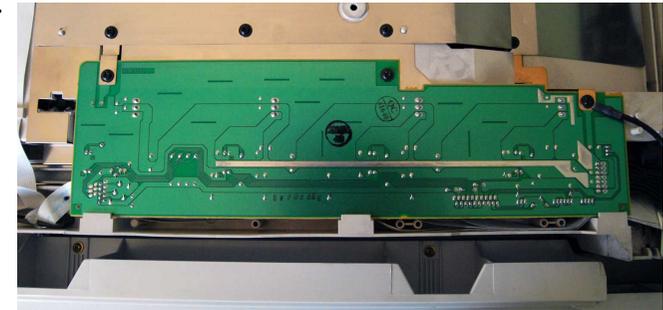
Step 4

The pcb is held in with three black screws and three plastic lugs. Remove the screws, and gently lift the earthing straps aside so that the board can be lifted up.

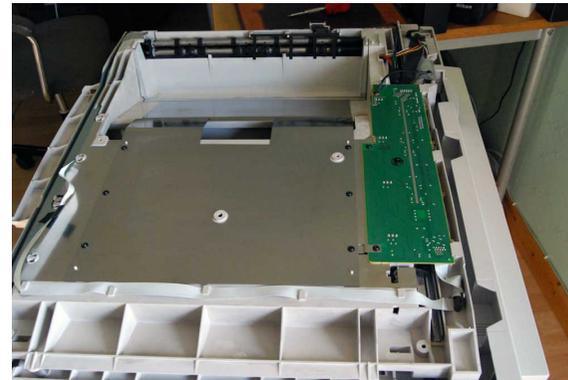
Step 2

Once the lid is removed, the green flag sensor pcb is seen, as on the right in the picture. This pcb will need to be lifted out of position to carry out the modification. First though, you need to disconnect the LED head wires which are attached to the other side of the pcb.

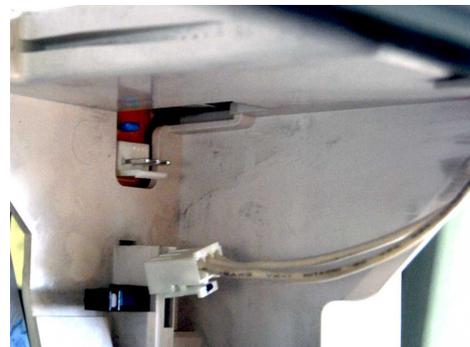
Step 3

Lift the cover of the printer and locate the four LED connectors. They need to be squeezed to release the catch, and then gently pulled off. You can just leave them hanging where they are. Close the cover again.

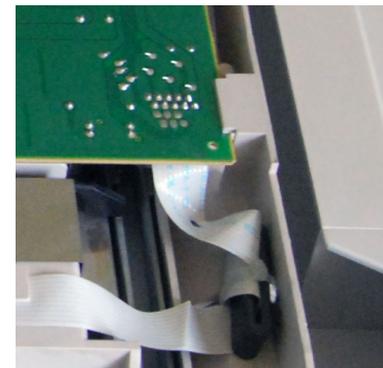
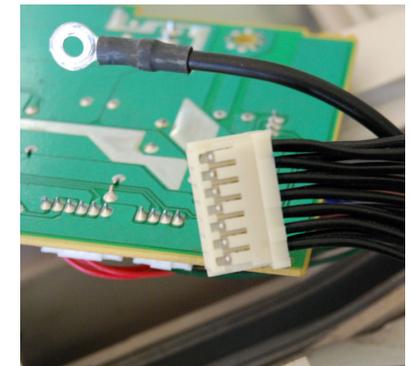
Step 5

Remove the connectors at each end of the pcb. They both simply pull out. Make a note of which way round the are, for later re-assembly.

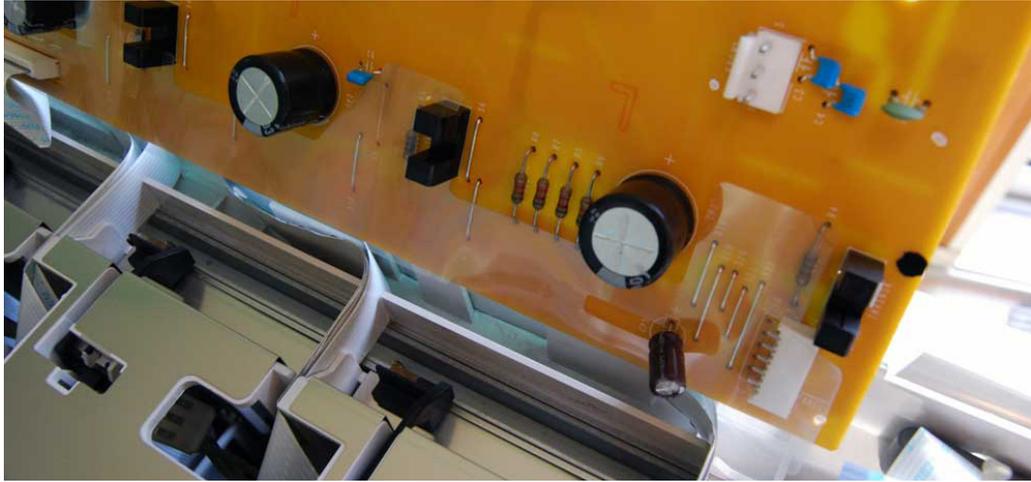
Step 6

Gently lift up the pcb to reveal the acetate insulating strip. This is designed to prevent the top edges of the ribbon cables from touching or shorting the components on the pcb.

Using scissors, make some cuts in the acetate to enable its easy removal. There is no need to remove anything else from the pcb.

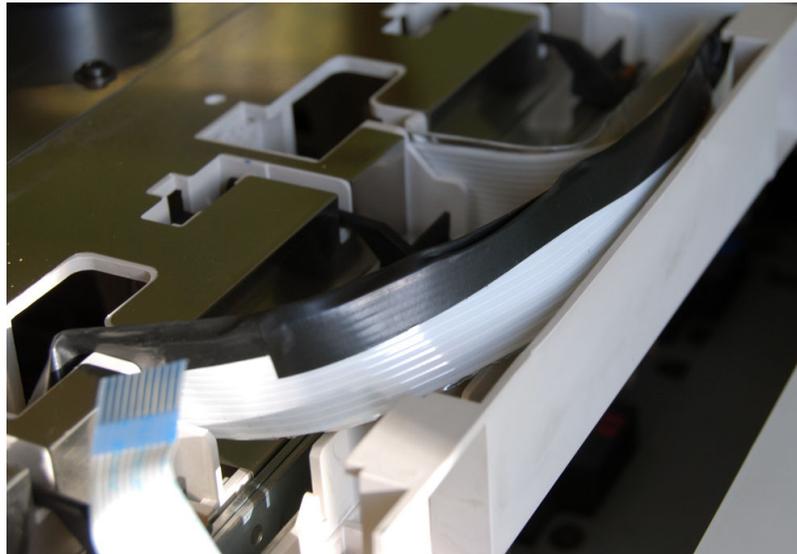
Step 7

To do the job of the acetate, cut some strips of insulating tape which need to be folded lengthwise along the top of the ribbon cables underneath the pcb. In order to stick them on, you will need to remove the ribbon cables from their guides, and then carefully relocate them afterwards. Getting them back in place so that the pcb can sit unimpeded back in its position is essential. Take time and care over this.

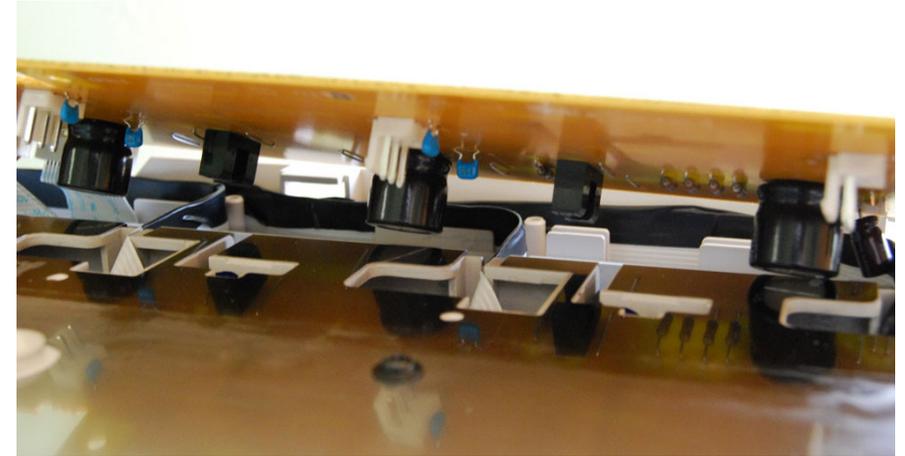
Step 8

Once all the ribbon cables are insulated, carefully check that the pcb can sit back in place without any obstructions. If you're happy that all's clear, locate the pcb under the plastic lugs, then lower the back and replace the screws. Take care to reconnect the earth wire and anti-static braces.
